EAST MAIN STREET

INFRASTRUCTURE
IMPROVEMENT PROJECT

2017

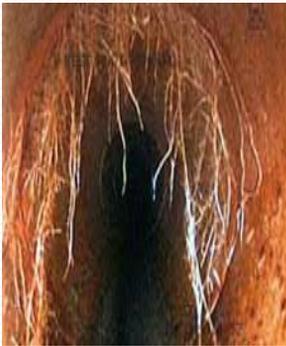
1728 FEET

of 8" to 20" CLAY SEWER MAIN REPLACED

- 131 YEAR OLD VITRIFIED CLAY SEWER MAINS WERE NOT INSTALLED TO CURRENT STANDARDS
- SEWER FLOW RESTRICTED WITH ROOT BLOCKAGES
- ALLOWED GROUND WATER TO ENTER INCREASING TREATMENT COSTS
- RESTRICTED ROUTINE MAINTENANCE AND INSPECTIONS DUE TO PARTIAL PIPE COLLAPSES
- PIPES NOT PITCHED CORRECTLY RESULTING IN SMELL AND SURCHARGE CONDITIONS

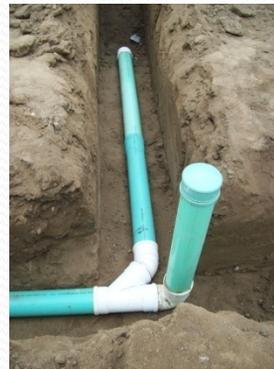
846 FEET OF 4" and 6" CAST IRON OR CLAY SEWER LATERALS
REPLACED WITH PVC WITHIN THE ROAD RIGHT OF WAY

40 TWO WAY CLEANOUTS INSTALLED
SEWER LINES CAN BE CLEANED OR INSPECTED
FROM CLEANOUT TO HOUSE OR CLEANOUT TO
SEWER MAIN WITHOUT OPENING SEWER IN HOME

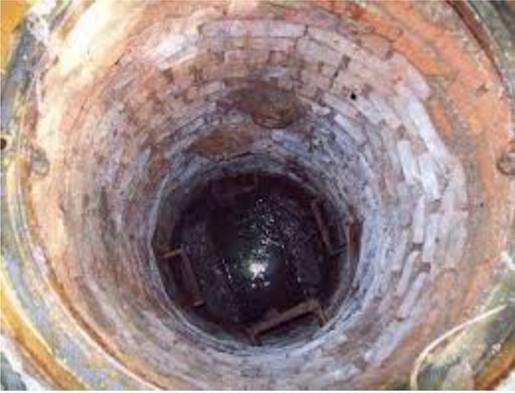
8 BRICK MANHOLES

REPLACED WITH
PRECAST MANHOLES

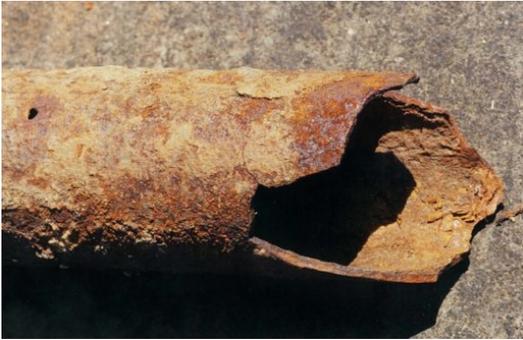
3070 FEET OF 1" to 10"
WATER MAIN REPLACED

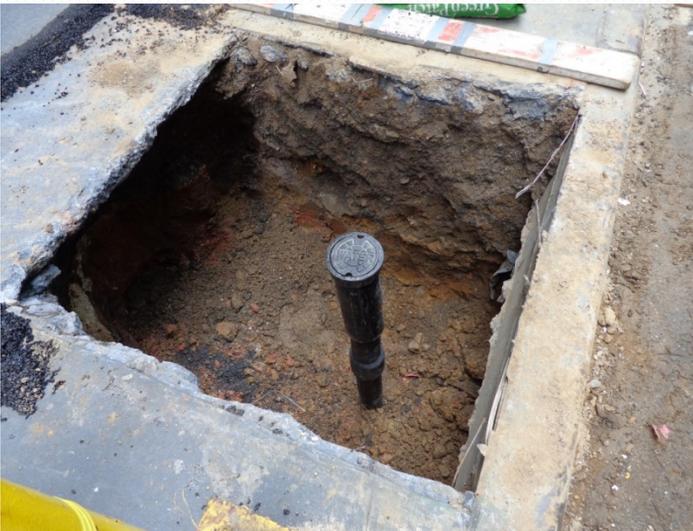
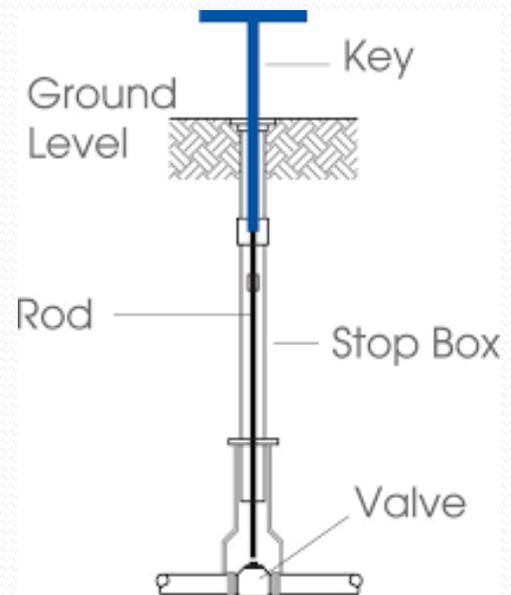
- 50 water shutoff or “curb boxes” replaced
- If the interior water shutoff fails in a structure water can be shutdown to the structure at the curb

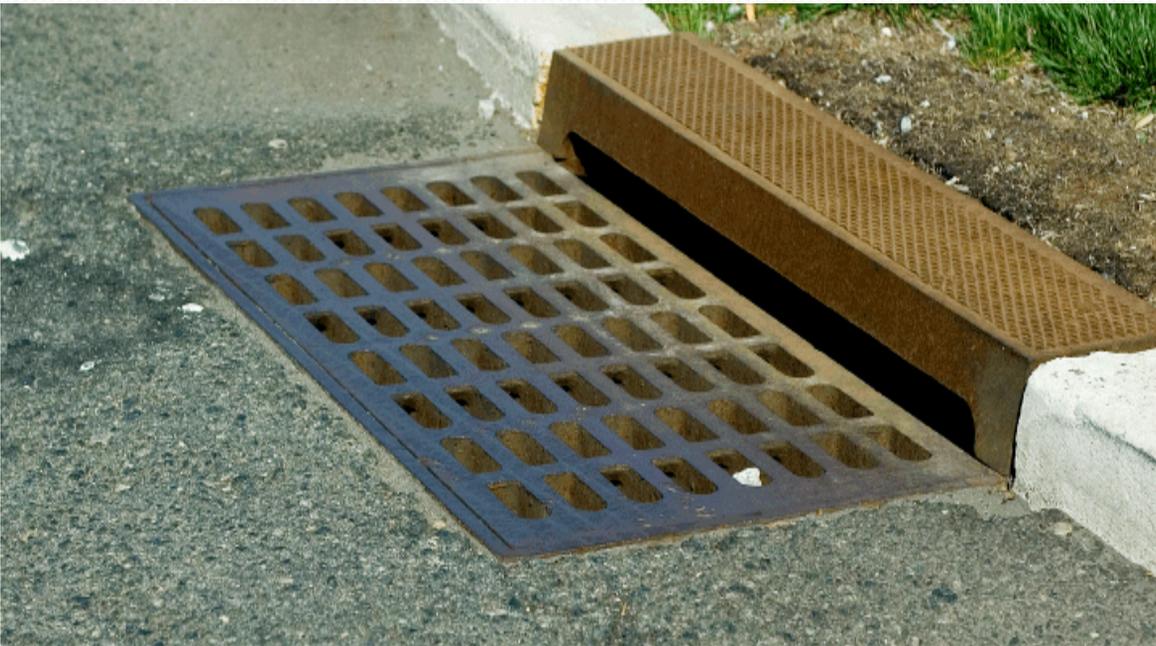
- 12 catch basins rebuilt or replaced

- Rebuilt storm water system will prevent water from freezing in winter and pooling in summer within the road
