EAST MAIN STREET

INFRASTRUCTURE
IMPROVEMENT PROJECT

2017

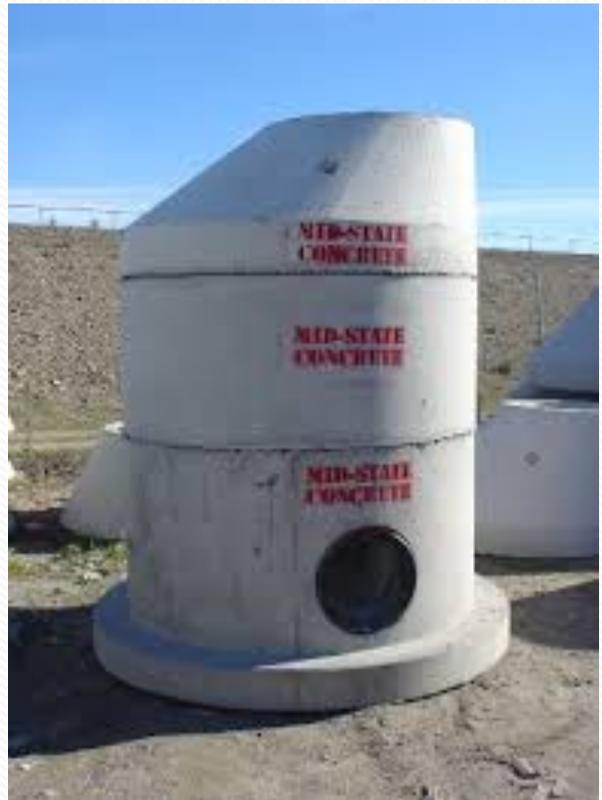
8 BRICK MANHOLES

REPLACED WITH
PRECAST MANHOLES

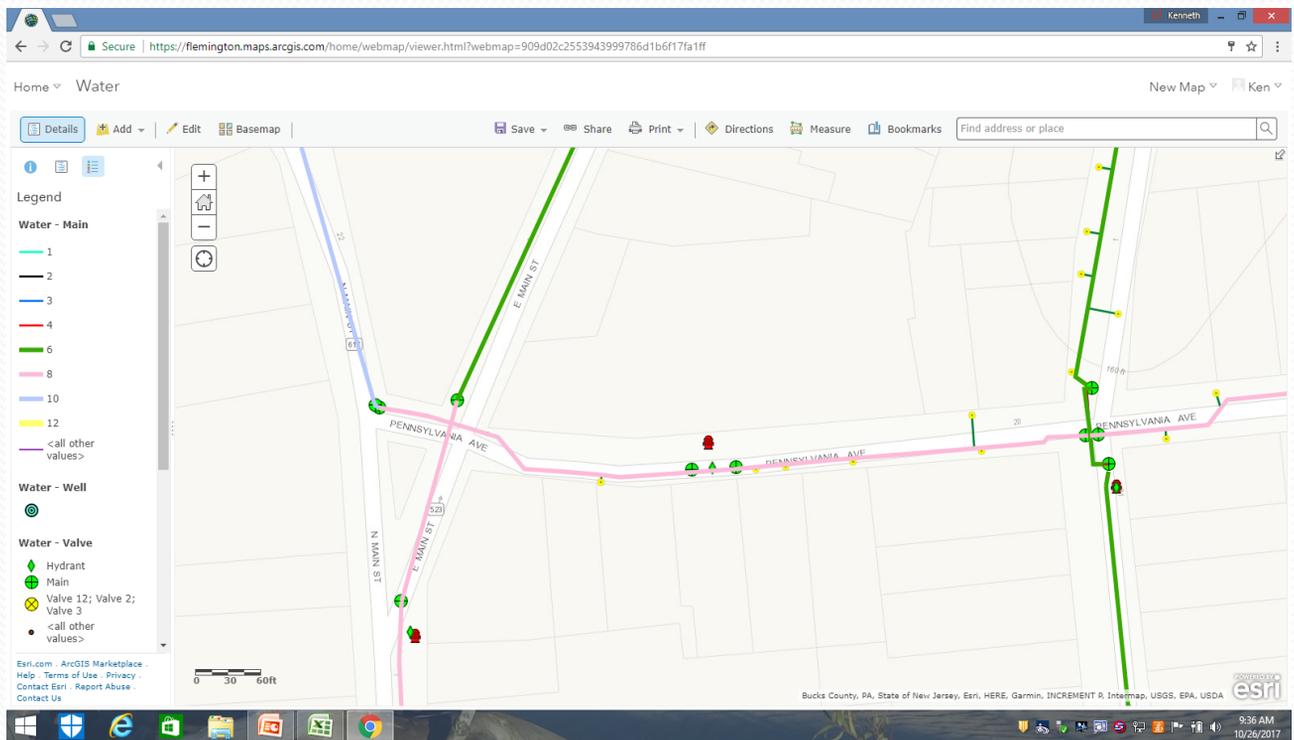
GIS / GPS PHOTO ARCHIVES

All storm, sanitary sewer, and water improvements have been mapped and represented within Flemington's GIS system.

- helps locate utilities faster in emergency situations

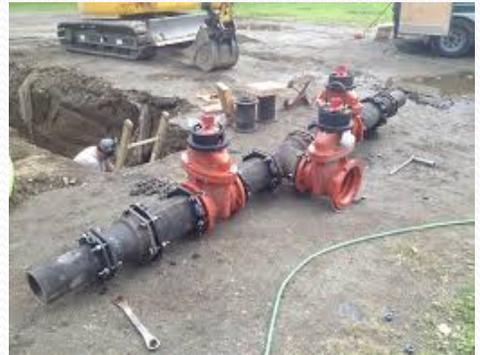
WATER SERVICES AND SHUTOFFS

- 50 water shutoff or “curb boxes” replaced
- If the interior water shutoff fails in a structure water can be shutdown to the structure at the curb
